B U L L E T I N

TB 6

SUBJECT: POSSIBLE WIRING ERROR IN 96K SENSOR HARNESS

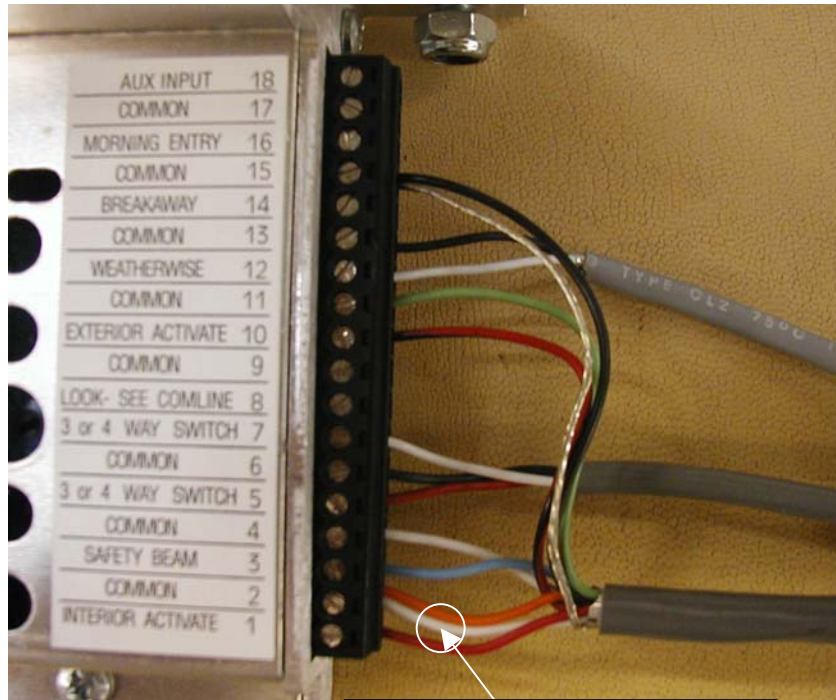
Cause: The sensor harness that plugs into the 96K Control Box is wired incorrectly. The wires connected to the breakaway circuit are attached in such a manner that the door control is always in breakaway mode. In this mode, the door ignores all activation signals and remains stationary.

WHITE WIRE IN INCORRECT LOCATION.

1. Loosen screw of connector position 2 "COMMON".
2. Remove white wire only from connector.
3. Verify that the orange wire is still properly inserted in connector position 2 and tighten screw.*
4. Insert (previously removed) white wire in terminal position 14 "BREAKAWAY" and tighten screw.*
5. Perform test of door system as outlined in 96K Instruction Manuals.

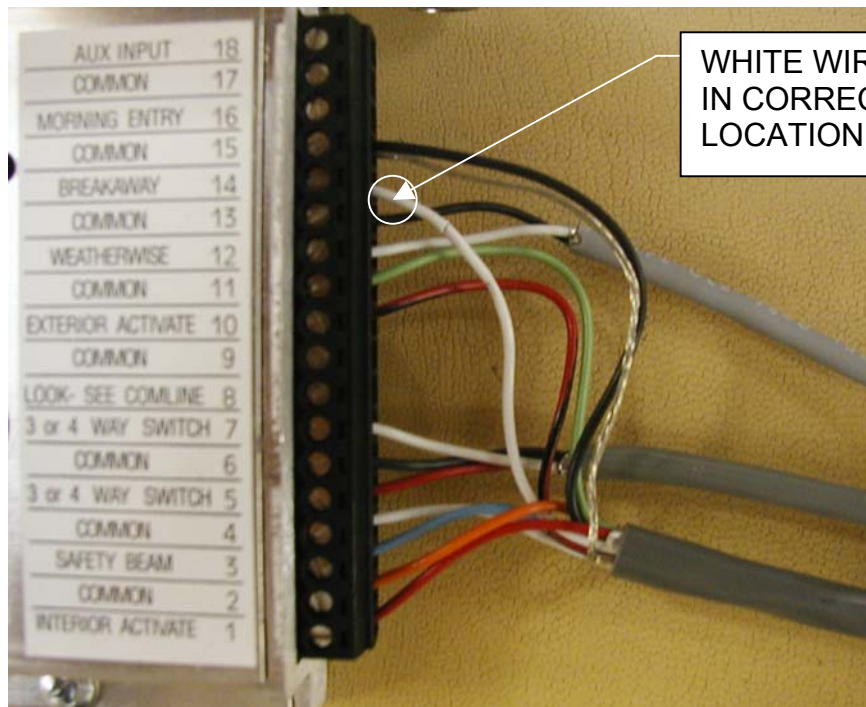
WHITE WIRE IN CORRECT LOCATION.

**Important note: When inserting wire into connector, care must be taken to ensure that the wire, not the insulator, is clamped down firmly when the screw is tightened.*
